# Flexural Behaviour of Pre-cracked Reinforced Concrete Beams Repaired with Adhesive Bonded Steel Plates

Sandile D Ngidi<sup>1</sup> and Morgan Dundu<sup>2</sup>

## Abstract

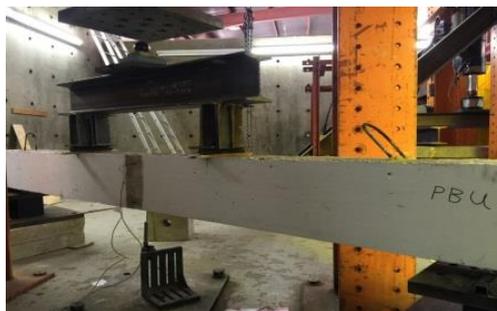
The beams were tested simply supported under a four point static loading system, over a span of 3000 mm. A linear variable displacement transducers (LVDT) was positioned at the mid-point of each beam in order to measure the vertical deflection. The testing configuration and instrumentation is shown in Figure 1. The tests were carried out using an Instron testing machine with an actuator capacity of 500 kN. The load was applied at a deflection rate of 2 mm/min to ensure that sufficient data was collected, until the beam failed. All measurements were recorded automatically at each load increment as the tests were performed. The control beams (Group 1) were loaded until failure attributable to the crushing of the concrete whereas the Group 2 and Group 3 beams were loaded up to their pre-cracking percentages of the load.

Figure 1: Test set-up

After 7 days of curing at ambient temperature, the repaired beams were instrumented and tested in similar fashion as the unrepaired beam. In this loading stage, electrical strain gauges were further used to measure the strain at the mid-point of the bonded steel plate. The distance between the support and the steel plate was kept constant at 35 mm for each beam. The test for each beam was stopped once the load showed a dramatic drop.

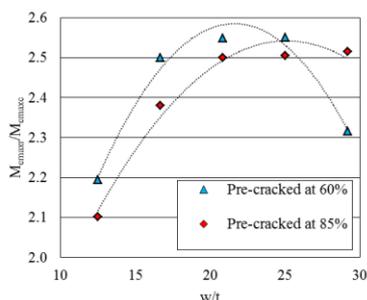
(a) ( $M_{emaxr}/M_{tmaxr}$ ) vs w/t ratio of plates

**Figure 2: The relationship between moment capacity and the width-to-thickness ratio**

In Figure 2(a), both graphs of Group 2 and 3 beams increased gradually from a width-to-thickness ratio of 12.5 to a peak of  $M_{\text{emaxr}}/M_{\text{emaxc}} = 2.55$  for Group 2 beams and a peak of  $M_{\text{emaxr}}/M_{\text{emaxc}} = 2.50$  for Group 3 beams, after that the graphs started decreasing gradually. This shows that there exists a limit in the width-to-thickness ratio of steel plates for which the load can increase. For the same width-to-thickness ratio, Group 2 repaired beams (pre-cracked at lower load) show greater maximum moment capacity as compared to Group 3 repaired beams (pre-cracked at higher load) for the first half of graph but quickly sheds the strengths much more than Group 3 beams. This behaviour was influenced by the stoppage of the Instron midway through the tests.

The theoretical moments of resistance of the beams were calculated using EN 1992-1-1 (2004) by assuming a rectangular stress distribution. Table 1 shows that the control beams, CB1 and CB2, were able to reach their full predicted flexural capacity since the ratio of the experimental maximum moment to the code-predicted moment of resistance of the control beam ( $M_{\text{emaxc}}/M_{\text{tmaxc}}$ ) was more than unity. Group 2 and Group 3 beams did not reach the code-predicted flexural capacity, as they all failed prematurely by debonding of the bonded steel plate. This means that no full composite action was achieved. Figure 2 shows that the ratio ( $M_{\text{emaxr}}/M_{\text{tmaxr}}$ ) decreased as the width-to-thickness ratio increased, implying that debonding was more dominant in the beams with larger width-to-thickness ratios. Some inelastic behaviour was found in beams repaired with steel plates of smaller width-to-thickness ratios, such as PBS1-75, PBS2-100 and PBU1-75. Such beams had a ratio of experimental moment of resistance to the code-predicted moment of resistance ( $M_{\text{emaxc}}/r/M_{\text{tmaxc}}/r$ ) of just less than 1.0.

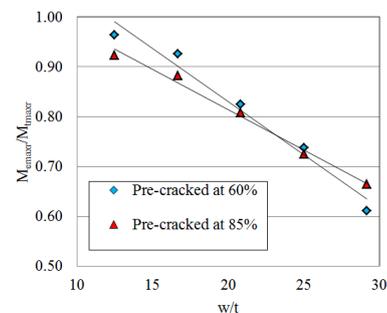
(b) ( $M_{emaxr}/M_{emaxc}$ ) vs w/t ratio of plates

The repaired beams were able to achieve load capacities that are more than twice that of the control beams. Group 2 beams, PBS1-75 to PBS5-175, achieved a range of 117% to 153% increase in load capacity when compared to the control beams, whilst Group 3 beams, PBU1-75 up to PBU5-175, attained a range of 108% to 150% increase in load capacity when compared to the control beams. The repaired beams achieved a maximum strength that ranges from 2.17 to 2.53 and 2.08 to 2.49 as compared to the control beams, for beams in Group 2 and Group 3, respectively. Except for specimen PBS5-175, there is a generally increase in the capacity of both Group 2 and 3 beams with increase in the width-to-thickness ratios of the steel plates. It is clear that the beams that were pre-cracked at a lower load level (serviceability load) reached higher strengths than beams that were pre-cracked up to 85% of the ultimate load of the control beams. It can be concluded that the level of pre-cracking does affect the moment capacity of repaired beams. Although Group 3 beams were pre-cracked almost to failure, plating not only restored the beam's original capacity, but doubled it.

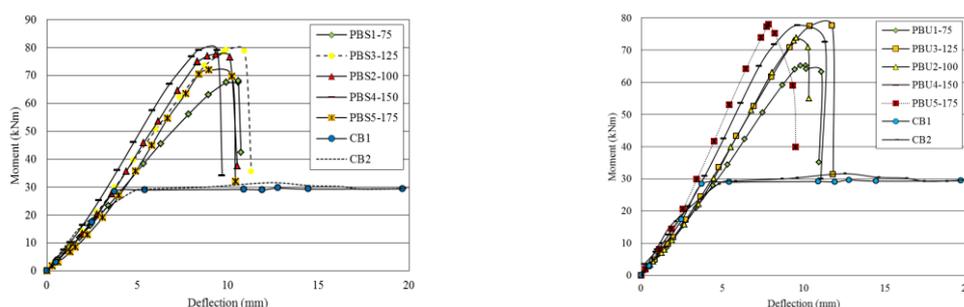
Figure 3 shows the moment-deflection curves of the beams tested in this study. The control beams shown in Figure 3 demonstrate stiffnesses that are similar to the repaired beams, which were maintained up to a moment of 28kNm. After this moment, the control beams experienced a significant drop in stiffness. These control beams' moment-deflection curves end with a horizontal line which indicates that the internal reinforcement was yielding. The high stiffness was maintained up to the maximum load in the repaired beams and this was caused by the increase in rigidity provided by the external bonded steel plate.

(a) Group 2

(b) Group 3

Figure 3: Moment-deflection curves of control and repaired beams

The steel plates provided additional stiffness for Group 2 and Group 3 beams to reach moment capacities that are 54% - 61% and 52% - 60% larger than the moments of the control specimens, respectively. This increase in the moment capacity is as a result of additional tensile forces and an increase in the lever arm provided by the external steel plate since it is bonded at an extreme position from the compression zone. The repaired beams show a reduction in deflections as compared to the control beams. The maximum experimental mid-span deflections was found to be 16% to 34% less than that of the control specimens for beams PBS1-75 to PBS5-175, respectively. The maximum experimental mid-span deflections for Group 3 repaired beams ranged from 7% to 38% less than that of the control specimens, for beams PBU1-75 to PBU5-175. The mid-span deflection is also observed to decrease as the width-to-thickness ratio of the steel plate increases, except for beam PBU3-125.

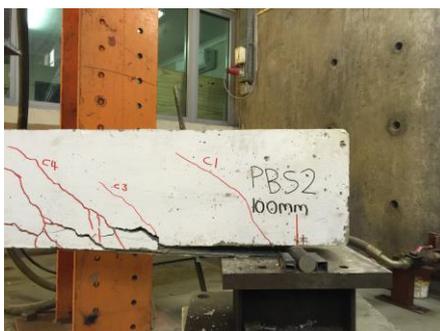
(a) PED (PBS2-100)

Figure 4: Plate-end debonding and delamination of the repaired beams

Two modes of failure were observed in the repaired beams, namely; plate-end debonding and delamination. Small diagonal shear cracks were observed, just before plate-end debonding occurred, due to interfacial shear and normal stresses at the plate-end curtailment (Oehlers (1992)). These cracks caused the end of the plate to separate from the concrete. As the plate separation propagated towards the mid-span, it transformed into shear diagonal cracks, which extended towards the loading point, at approximately 45°.

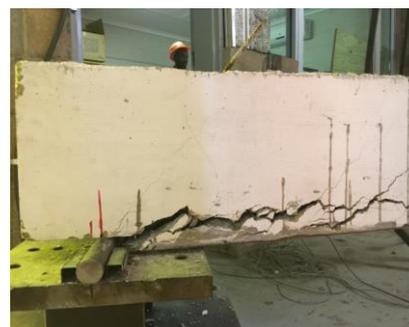
(b) Delamination (PBS1-150)

Similar to plate-end debonding, delamination started as a small diagonal crack at the plate-end curtailment, as a result of a change in stresses between the steel plate and concrete. In delamination, the crack extended to the tensile reinforcement. As the loading was increased, the crack propagated along the reinforcing bars towards the mid-span. Since the shear and bending stresses are high at the loading point, this forced the crack to change direction and to propagate at about 60° towards this point. Table 1 shows that, beams with a smaller width-to-thickness ratio failed by plate-end debonding and those with a larger width-to-thickness ratio failed by delamination. This means that the mode of failure was also dependent on the amount of external reinforcement used.
